USACERL Technical Report E-91/08
July 1991

Evaluation of Central Heating Plant at Rickenbacker Air National Guard Base

by
Martin J. Savoie
John Gostich
J.W. Chappell
John Richards

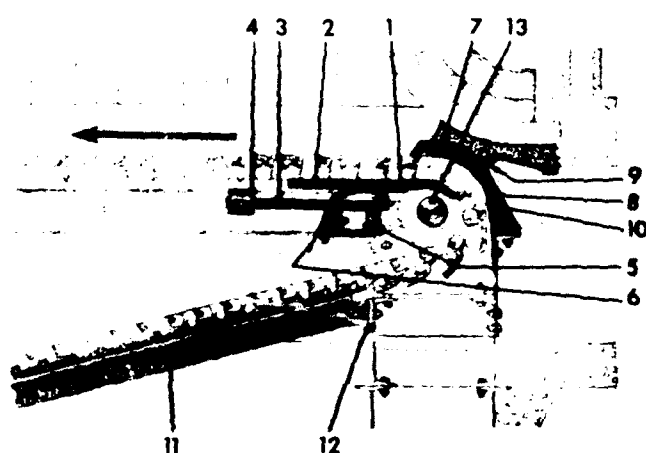
Figure 7. Detroit stoker rear grate seal and deflector tuyeres.

A typical repair item for all four boilers was the rear grate seals. On boiler No. 8, a Detroit Stoker, these are called the rear grate seal tuyeres (Figure 7). On boilers Nos. 4, 6, and 7, Riley Stokers, they are called rear grate refractory-filled air seals (Figure 8). These seals prevent air leakage at the rear of the grate surface and, in conjunction with the front and side seals, maintain minimum excess air in the furnace.

Boiler No. 8 - Detroit Spreader Stoker	<ul style="list-style-type: none"> ** Replace eight rear grate seal tuyeres ** Replace all feeder blades on Feeders Nos. 1 and 2 (left to right facing boiler front) ** Replace all feeder plates and spilling plates
Boiler No. 7 - Riley Spreader Stoker	<ul style="list-style-type: none"> ** Replace worn rear grate refractory
Boiler No. 6 - Riley Spreader Stoker	<ul style="list-style-type: none"> ** Replace refractory on rear grate air seals
Boiler No. 4 - Riley Spreader Stoker	<ul style="list-style-type: none"> * All refractory filled air seals including support channels need to be replaced * Approximately 70% of skid shoes need replacement. * Replace front air seals cut by worn skid shoes. * Replace drive shaft and idler shaft bearings * Drive shaft sprockets should be reversed to obtain new bearing surface, or replaced * Two feeders need new arm pins and rollers for a correct pusher box stroke * Replace deflector tuyeres on all three feeders

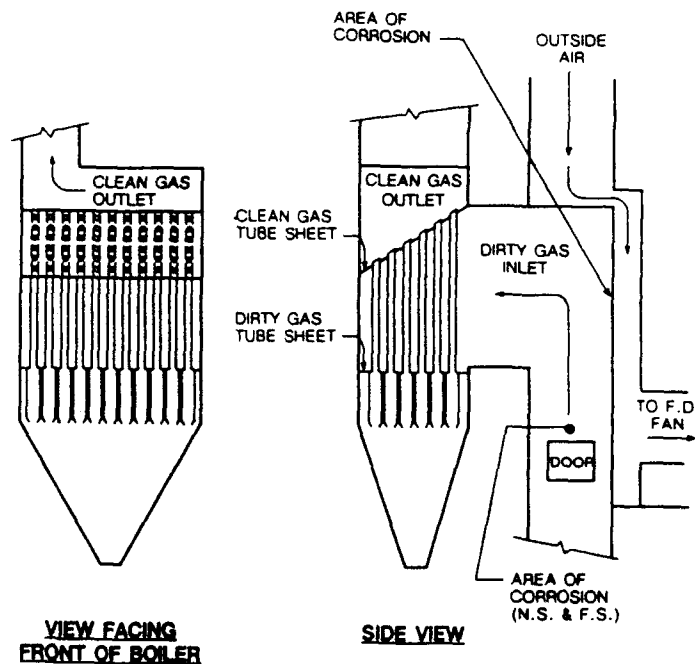
Figure 14. Rickenbacker ANGB multicyclone collector schematic.

stack to provide additional air to optimize scrubber operation. The combination of the cold makeup air, infiltration from offline boilers, and high sulfur coal had caused the flue gas to drop below the acid dew point throughout the duct. This caused severe corrosion in the common duct, leaving holes in the duct work, which caused more air infiltration. The following repairs are recommended (to be done before testing) to alleviate the infiltration problems:

It was necessary to minimize the amount of air infiltration into the flue gas going to the common mechanical dust collector and on to the scrubber system to avoid an acid dew point condition at the collector inlet during upcoming stack testing in February. It was believed that the load demand in February would be sufficient to produce the required gas flow through the scrubber system with only minor regulation of outside air through the damper. The flue gas inlet temperature to the mechanical dust collector must be kept above the acid dew point temperature to maintain mechanical collector efficiency, or certain operational problems occur.

1. Seal off the open end of the breeching duct to eliminate uncontrolled air infiltration into flue gas flow.
2. Repair controls for the common breeching damper for regulation of desired air infiltration.
3. Patch areas of the common breeching, especially the common dust collector inlet expansion joint.

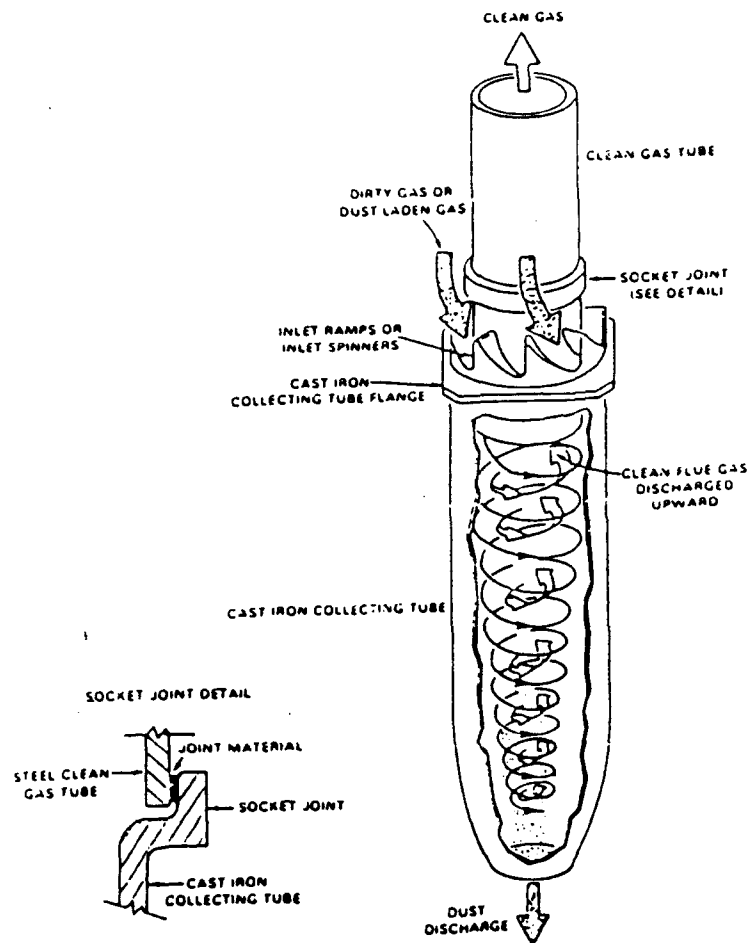
Figure 15. Collector tube and socket joint schematic.

Figure 15 shows a typical collector tube configuration with a socket joint detail. The sketch shows that, if the socket joint is not sealed, dirty gas will flow through the joint and on to the clean gas flow, resulting in a lower dust collection efficiency. Table 4 summarizes the recommended repairs on the boiler multicyclone collectors.

When all or a portion of the flue gas drops below the sulfur trioxide dew point temperature, the inlet vane, ramp, or spinner of the cast iron collecting tubes (Figure 15) gets wetted by the weak solution of sulfuric acid, and fly ash particles stick in this wetted solution. When the flue gas temperature is increased above the sulfur trioxide dew point temperature, the water is evaporated out of the wetted solution and a thin layer of hard (concrete-like) material remains on the inlet vanes, ramps, or spinners. Repeated cycling above and beyond this dew point temperature causes the layer of hard material to build until the flow pattern and quantity of flow through the individual tube is reduced.

The thin layer of hard material is very rough in texture because only large fly ash particles stick to the wetted surface. This rough-textured surface causes uneven centrifugal forces and flow into the cast iron collecting tube, which disrupts the dirty-flue-gas/clean-flue-gas vortex. When the vortices are disrupted, re-entrainment of the fine fly ash particles occurs, greatly decreasing the efficiency of the mechanical dust collector.

Boiler	Recommendation
4	** Repair corrosion holes in dirty gas inlet breeching walls Repair 1 socket joint leak Repair dirty gas tube sheet leakage
6	** Repair corrosion holes in dirty gas inlet breeching walls ** Repair 7 socket joint leaks
7	** Repair corrosion holes in dirty gas inlet breeching walls ** Replace 4 cast iron collecting tubes
8	** Repair 8 socket joint leaks
	** Repaired prior to testing

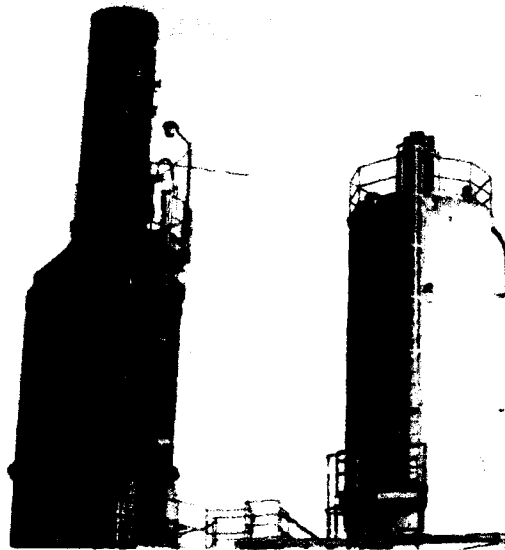
Figure 19. Rainout deposits on scrubber shell and adjacent lime silo.

Inspection results indicated significant liquor re-entrainment from the scrubber stack. One of the clearest indicators of this condition was the persistent rainout of large droplets which occurred within 40 yds downwind of the scrubber system. The rate of deposition was roughly equivalent to a constant, heavy drizzle. The droplets also hit the scrubber support structure, the lime storage tank, and other equipment in the immediate vicinity.

Photographs shown in Figures 19 and 20 clearly show the stains resulting from the scrubber liquor salts and fly ash that remain as the droplets dry.

The rainout conditions created several problems. During cold weather operation, the freezing liquor created slip hazards on the concrete pad and ladders around the scrubber system. Also, the salt-laden droplets in the stack could have affected particulate emission test results. Based on the observed conditions, the reduction of liquor re-entrainment was considered necessary.

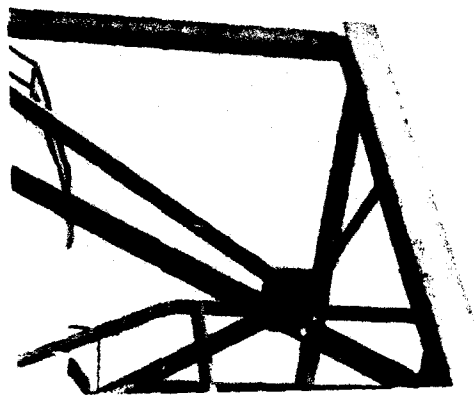
Figure 22. Dissipating water droplet ("steam") plume with very low residual opacity.

Stack Appearance. The presence of a condensed "steam" plume is an indirect indication of adequate liquor recirculation flow. The lack of this plume would indicate a severe scrubber malfunction. There should be less than 5 to 10 percent opacity in the residual plume when weather conditions allow the condensed "steam" to dissipate. Proper plume appearance is shown in Figure 19 (Chapter 4) and Figure 22. There should also be very little, if any, rainout of salt-laden droplets from the stack.
